**INSTALLATION AND FLIGHT TEST OF DRAGLESS ANTENNAS FOR USE WITH
VHF HOMING EQUIPMENT IN F-80, F-86, AND F-84 AIRCRAFT**

**SHERLA L. STUTZ
COMMUNICATION AND NAVIGATION LABORATORY**

AUGUST 1952

WRIGHT AIR DEVELOPMENT CENTER

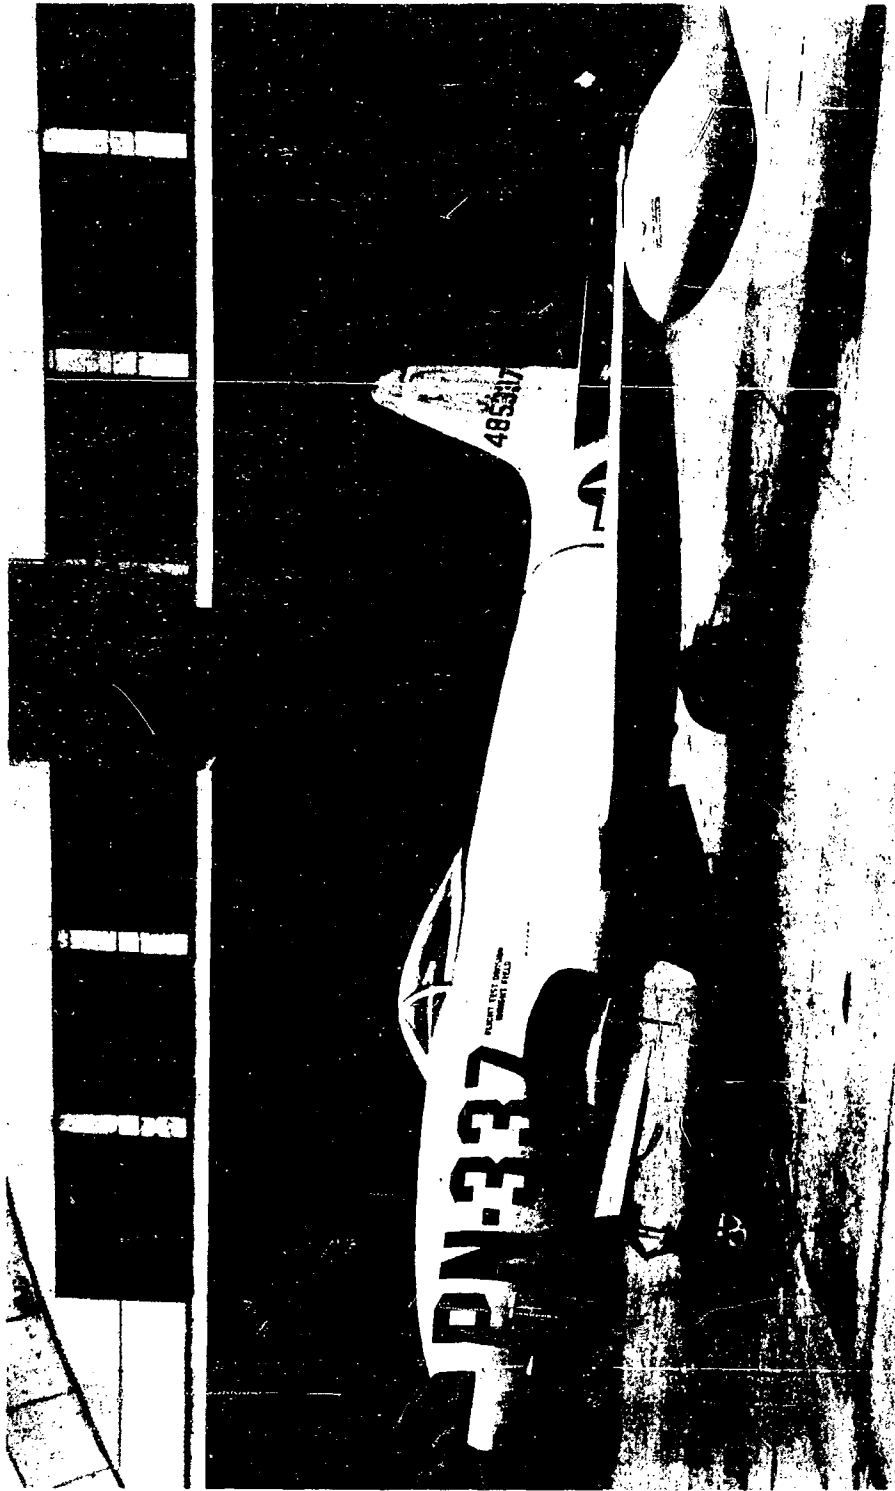
Fig. 4

FLUSH-MOUNTED ANTENNAS FOR RADIO SET AN/ARC-3 AND HOMING ADAPTER AN/ARA-8
IN F-80 AIRPLANE 5337

FLIGHT SUMMARY DATA NO. 1.-- A flyable antenna system manufactured in the laboratory and installed in the flying F-80A pictured in Fig. 4. A few preliminary flight tests were conducted on the aircraft for pilot familiarization. The equipment was then transferred to another F-80A model and a series of planned flight tests were conducted. During the twenty-two flights, of testing the antenna system, it was learned that the patterns were satisfactory providing the aircraft attitude did not exceed the following:

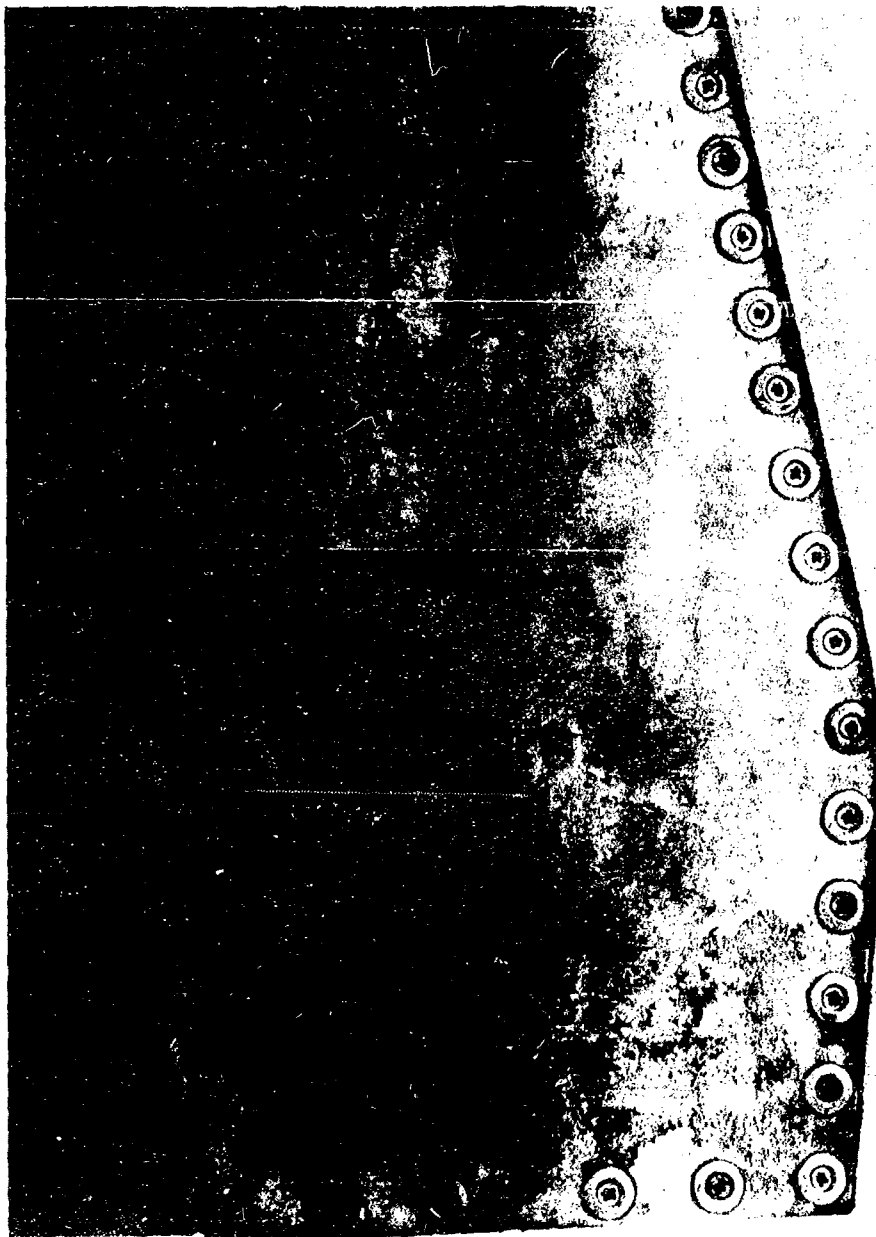
FLUSH-MOUNTED ANTENNA PANEL FOR HOMING ADAPTER AN/ARA-8.
IN F-80 AIRPLANE, SERIAL NO.5337.

See Fig. 5 and 9. Fig. 5, pictures a good antenna panel structural design. Fig. 9 pictures results of exposure to a high speed and low temperature conditions on a make shift panel design. The surface impregnant cracked and blew away as a result of the rapid pressure changes that occurred while at the low temperature. The antenna should be designed for exposure to long periods (several minutes time) of bombardment from rain or ice pellets traveling at rates of speed in the order of 13 to 1400 feet per second. The antenna system is, wherever possible, designed to be placed in the aircraft skin in other than symmetrical locations (centerline of top and/or bottom of fuselage) to eliminate the necessity for cutting into any of the main longerons, formers or bulkheads. In the design of the antenna panel the physical shape and size is adjusted as nearly as possible to the configuration and dimensions of the section of the aircraft surface into which it is to be installed. The antenna panel is, wherever possible, placed in a section of the aircraft surface that is unpressurized and that has approximately equal normal pressures both inside and outside, while in flight. If the pattern studies of the particular aircraft will permit and the opportunity presents itself the panels are designed to replace existing access or inspection doors. This procedure permits ready fabrication, installation, replacement and/or modification, when and if the aircraft is already in production status. Such an antenna is pictured in Figures 10, 11, 12 and 13. To counteract forces and effects of low temperatures and rapidly changing pressures the antenna panel is designed of "void free" laminated, structural plastic incorporating reinforcing ribs, and impregnated with the proper and not excessive amount of low loss (electrical) binder plastic. The antenna panel is (in addition) coated with an outer skin of vinyl plastic or rubber which increases its resistance to rain and ice particle erosion. Due to the location and size of various other aircraft components that may be installed near the antenna panel it is sometimes necessary to use metallic backing thus forming a cavity behind the panel to reduce the mutual coupling between the panels and other aircraft equipment or stray (RF) fields. The resulting cavity should be an appreciable portion of a wavelength deep whenever possible so as not to result in an unfavorable antenna impedance and/or lowered "Q". The employment of a cavity behind the antenna panel makes it possible to achieve a balance between the elements of the antenna system more easily than without.

Fig. 9 pictures the results of a combination of high altitude (low temperature) and rapidly changing pressures on the inside and outside of the aircraft structure at the point where the antenna was installed. You will note from the photograph that a large portion of the surface coat of impregnant has broken loose and blown away. When the panels were fabricated, a surplus of impregnant remained on the surface, aggravating the condition. The breakdown of the surface could have been prevented for a much longer period of time by the increased reinforcement of the panel, a coating of vinyl plastic or rubber, and the proper amount of impregnant permitted to remain on the surface of the panels during manufacture.
